Archaeologist says entire Western Wall is ‘danger zone,’ public should stay away

Warning of ‘multiple cracks’ after boulder falls, Zachi Dvira says people should not be allowed near holy site — neither in the mainstream prayer pavilion nor at Robinson’s Arch.

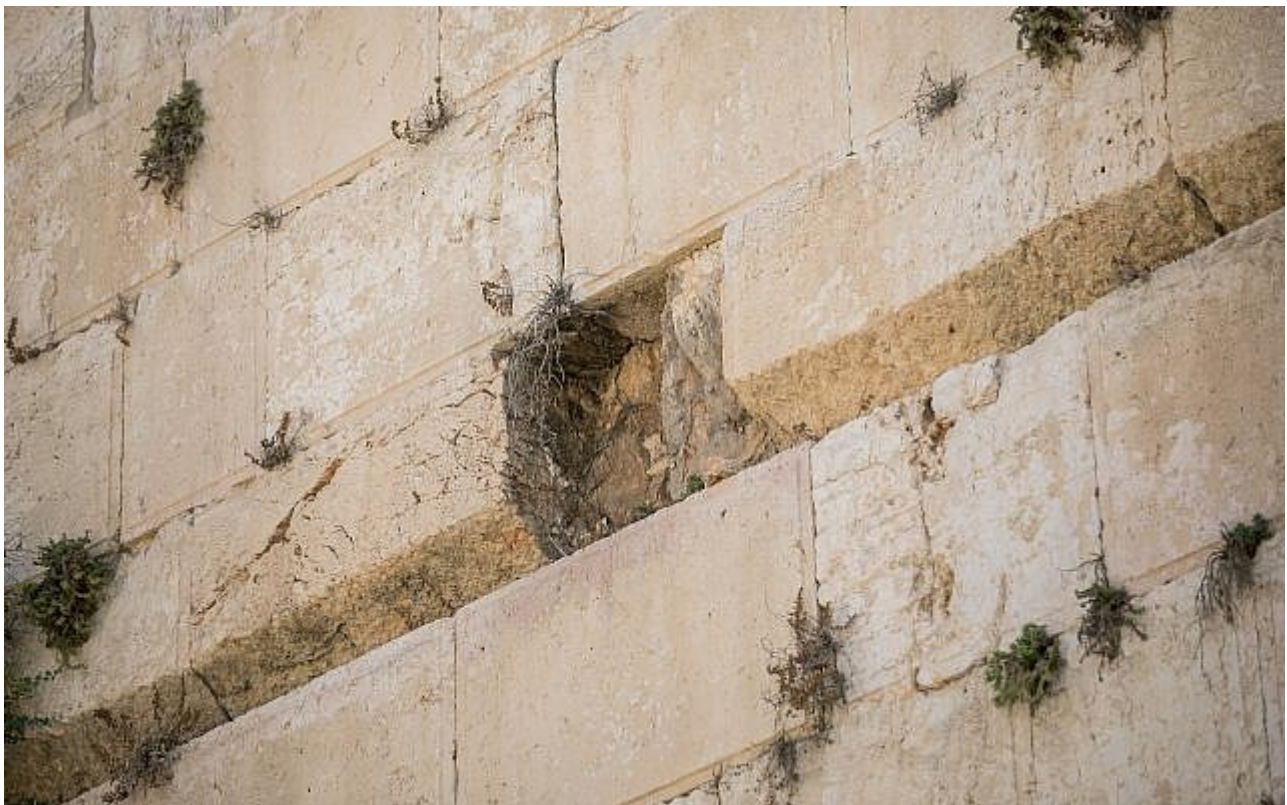
View of the site where a large chunk of stone dislodged from the Western Wall in Jerusalem at the mixed-gender prayer section on July 23, 2016. (Yonatan Sindel/Flash90)

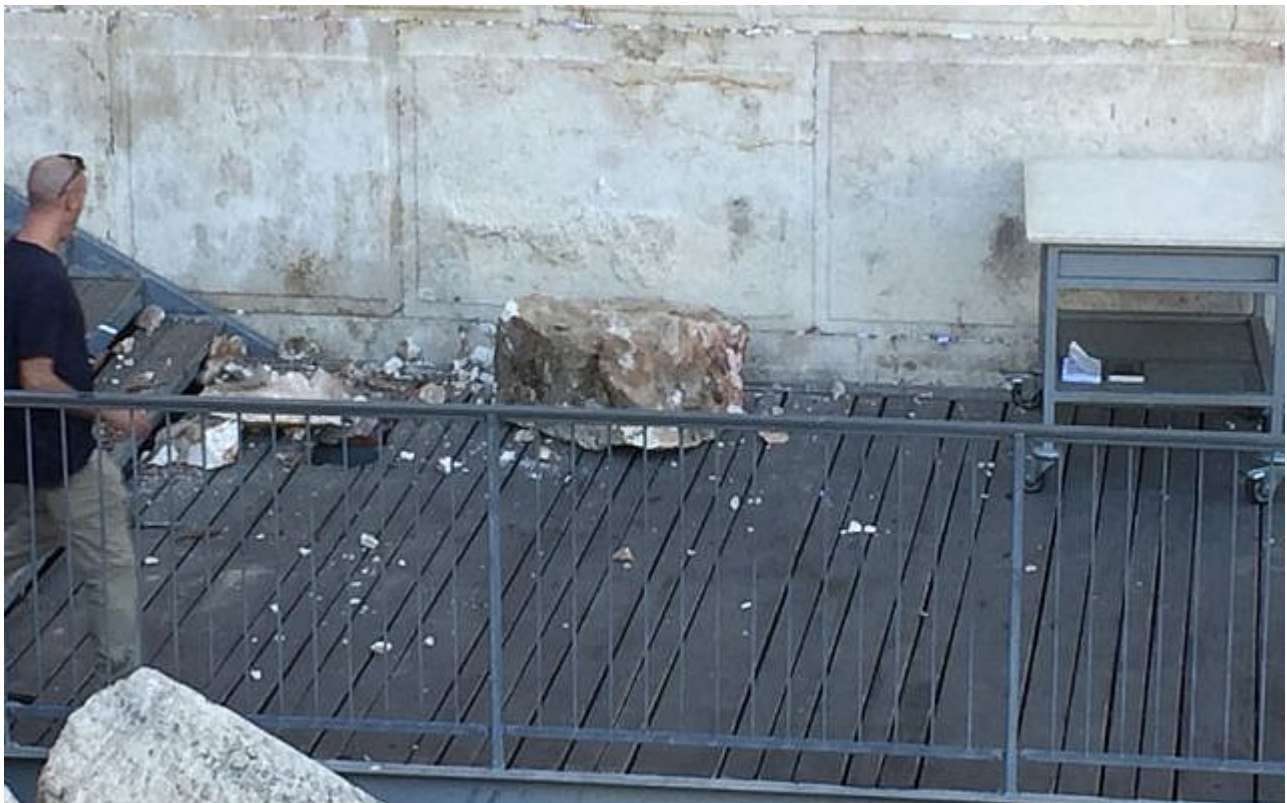
A boulder from the Western Wall falls onto a prayer platform on July 23, 2018 (Courtesy/The Western Wall Heritage Foundation via the Masorti Movement of Israel)

On Monday morning, a boulder fell from the Western Wall onto the Robinson’s Arch egalitarian platform, which is located in the Davidson Archaeological Park alongside the Wall. Captured on film, the rock landed very close to a female worshiper there.

The fallen boulder weighed about 220 pounds (100 kilograms), Israel Radio said. It damaged the platform on which Daniella Goldberg, 79, was praying.

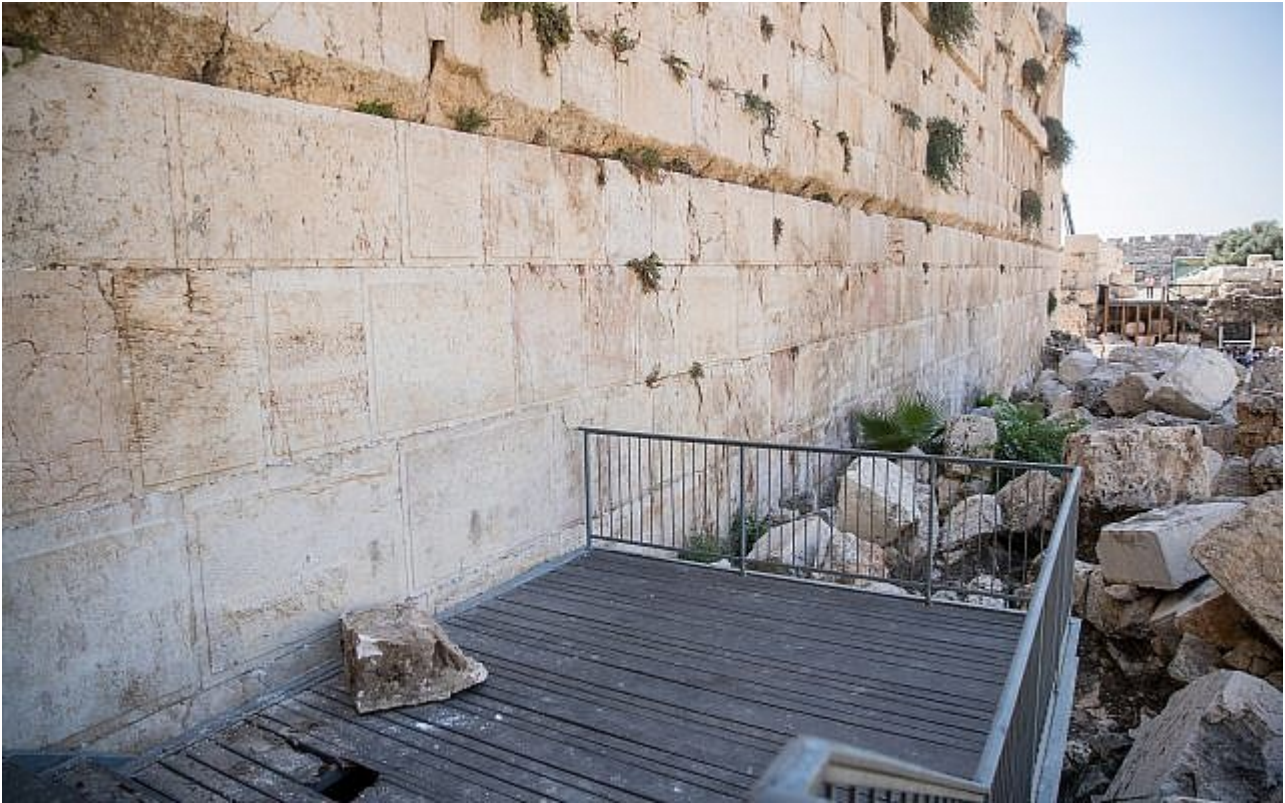
A boulder from the Western Wall falls onto a prayer platform on July 23, 2018 (Yonatan Sindel/Flash90)

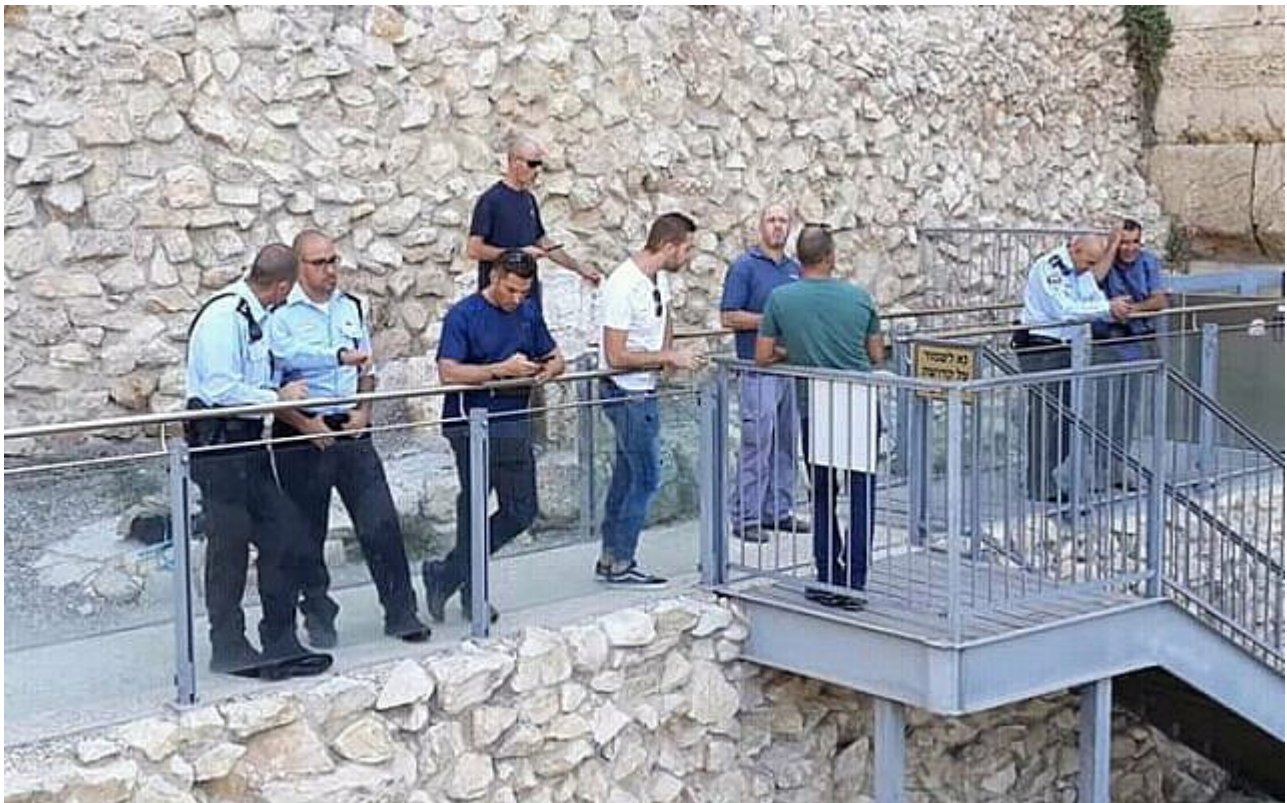
A team of professionals was deployed to the Robinson's Arch egalitarian prayer platform next to the Western Wall on July 23, 2018 following the fall of a Herodian stone. (Courtesy the Masorti Movement/Rabbi Valerie Stessin)

In a statement, the IAA said there were a number of possibilities that may have led to the stone's fall, such as vegetation growing in the wall's cracks, or entrapped moisture that may have led to the stone's wear. There is also the possibility of a still unknown engineering failure.

“With the help of advanced technological methods, IAA experts will begin careful monitoring in the area of the fall, as part of a survey of the entire area and the formulations of recommendations for the elimination of such danger,” said the IAA. “The Israel Antiquities Authority is aware of the sensitivity required in handling this case and will work in cooperation with all the relevant bodies.”

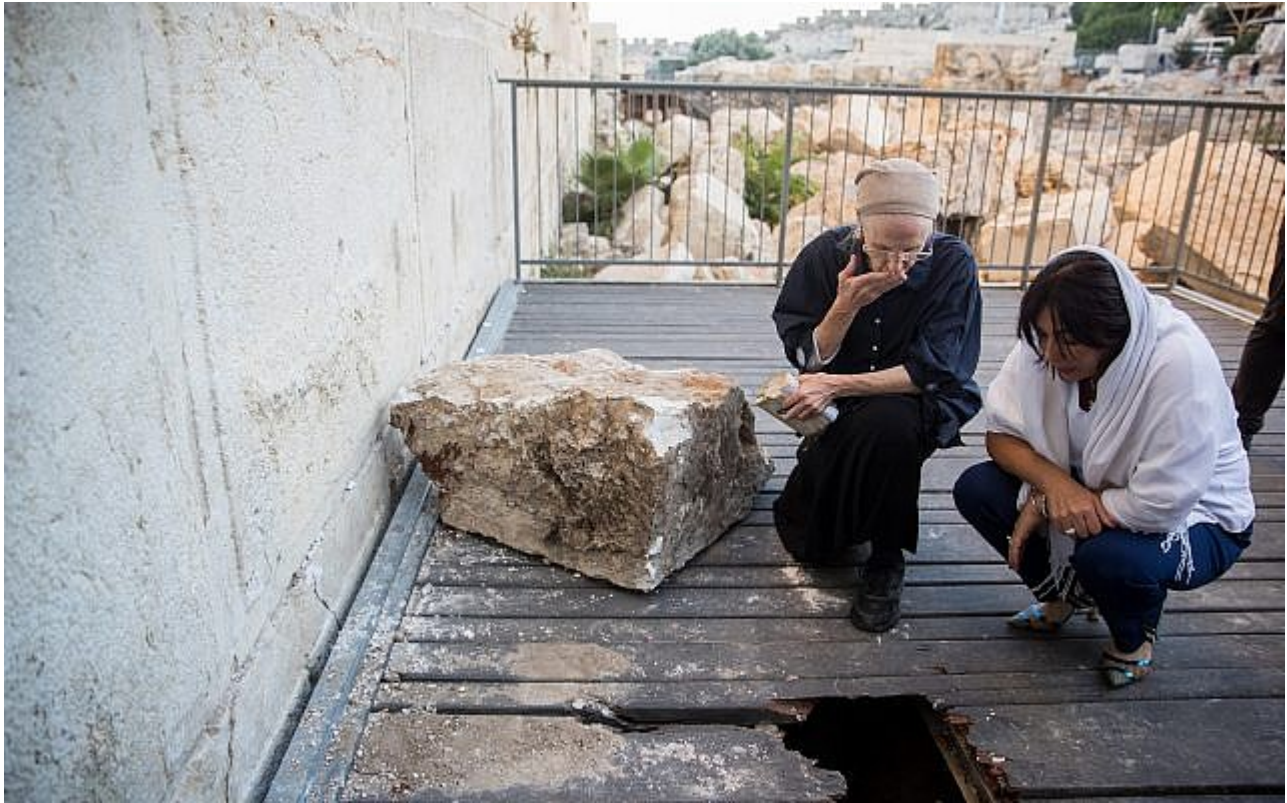
Daniella Goldberg (left), with Culture Minister Miri Regev, inspects the damage caused by a large stone that dislodged from the Western Wall in Jerusalem Old City on July 23, 2013, at the mixed-gender prayer section. The boulder fell close to where Goldberg was praying. (Yonatan Sindel/Flash90)

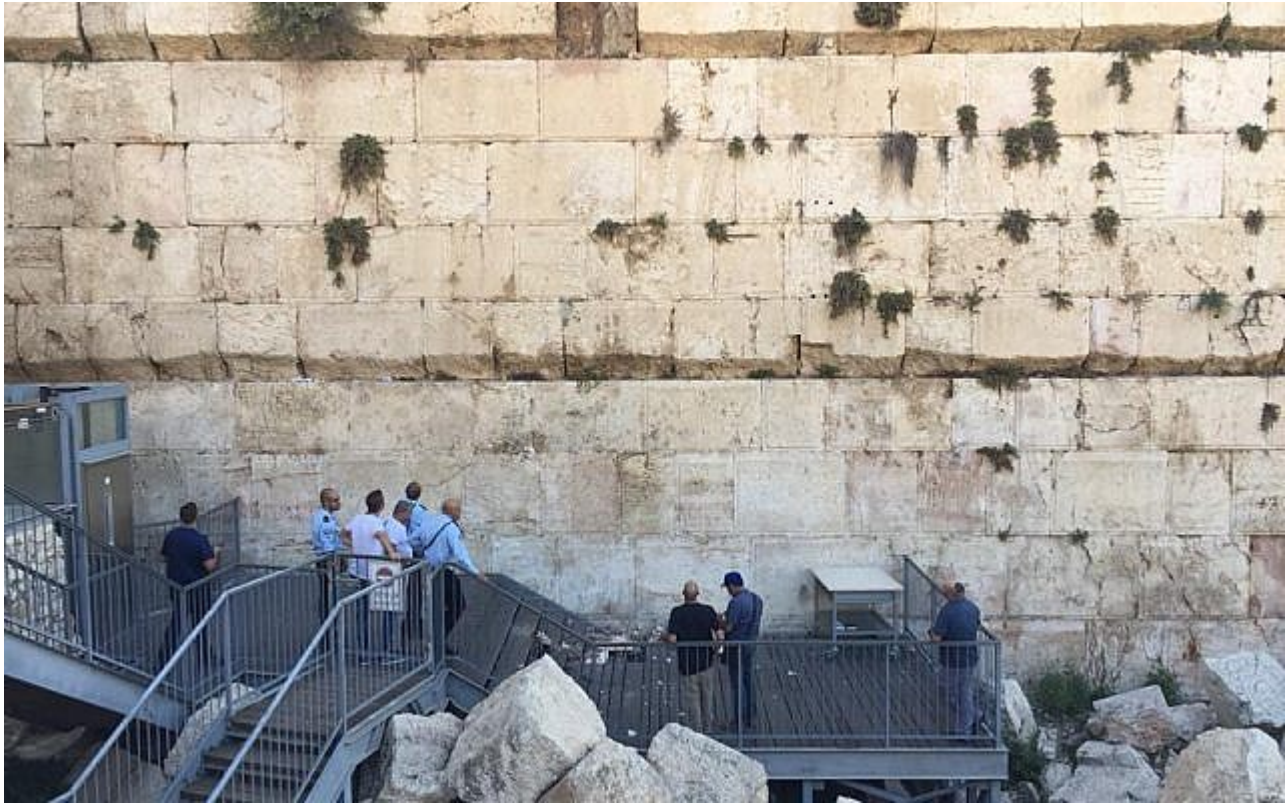
Israel Antiquities Authority professionals assess damage at the Robinson's Arch section of the Western Wall after a stone fell on July 23, 2018. (Hannah Estrin)
